Manhole Inspection Summary

Manhole # S39I__021MH

Insp Date: **3/27/08 2:38 PM**

Location Address: **slemmers alley**

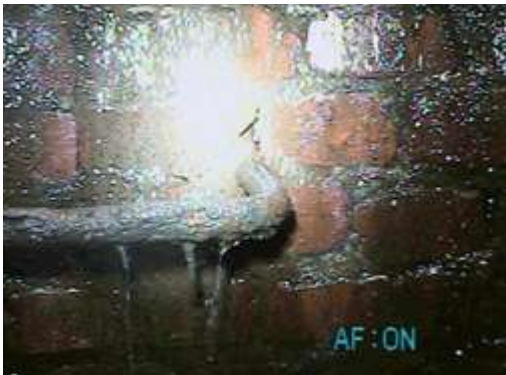
Miscellaneous

water from corbel running off steps

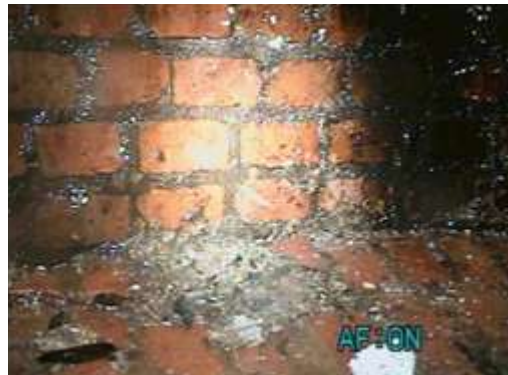
Defect 8

weeping from barrel wall

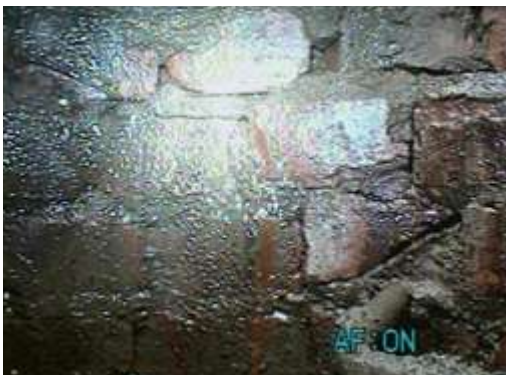
Defect 6

Condition: ☐ Sound ☒ **Cracked** ☐ Root Intrusion ☐ Loose Brick ☐ Deteriorated

cracked corbel

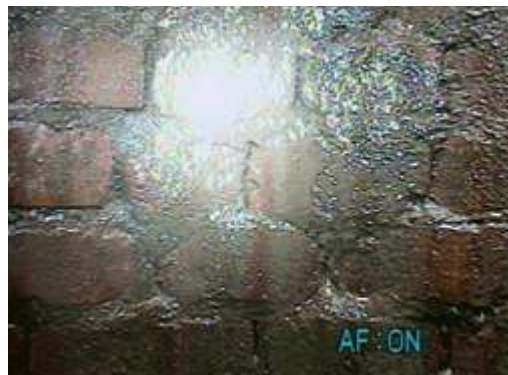
Defect 4

Infiltration: ☐ None ☐ Joint ☐ Cracks ☐ Mortar ☐ Roots ☒ **Wall**

weeping from corbel wall

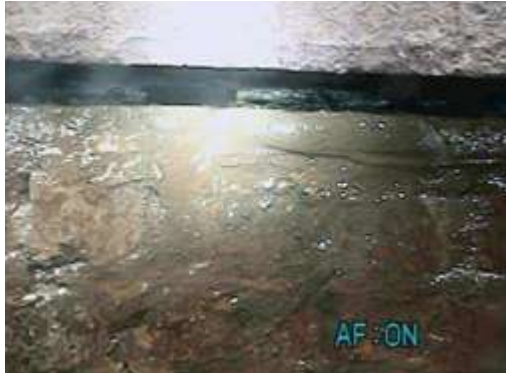
Defect 3

Comments **There is a steady flow of water from top of frame on one side and infiltration all around manhole**

Infiltration: ☐ None ☒ **Joint** ☐ Cracks ☐ Mortar ☐ Roots ☐ Wall

steady flow of water from chimney joint

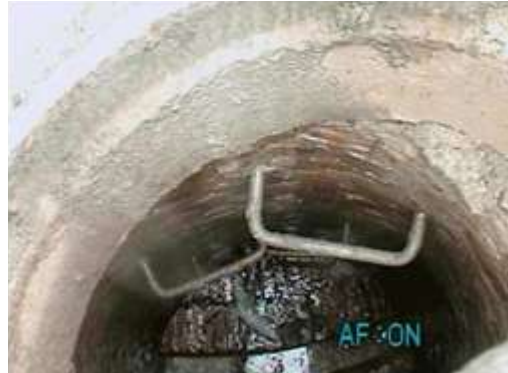
Defect 2

☒ **Leaks**

infiltration from frame
